PROPERTY INSPECTION REPORT

Report #: RF20100331-01

Concerning: 1313 Mockingbird Lane, McAllen, TX -
(Address of Inspected Property)

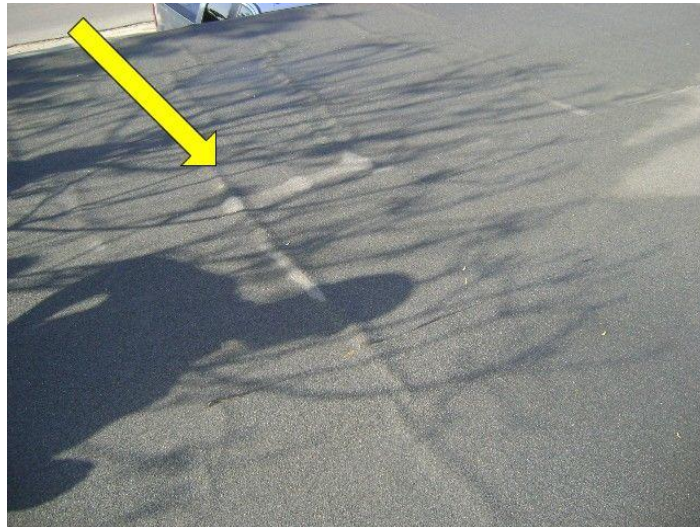
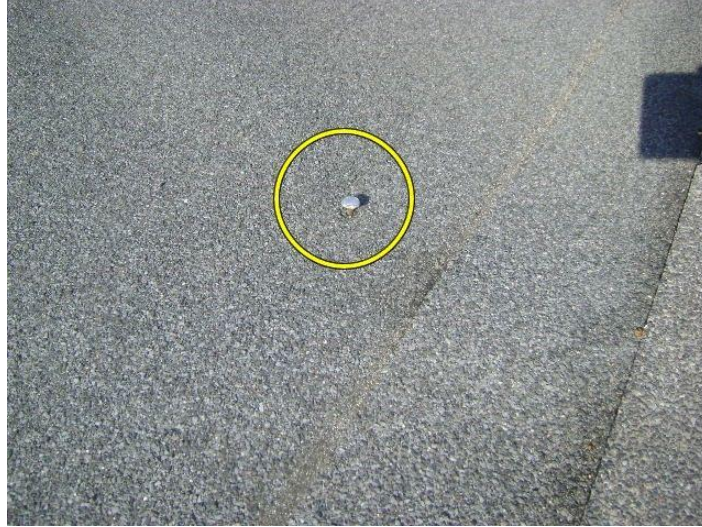
C. Roof Covering Materials

- þ Carport covering is improperly installed with improper material. This must be corrected.
- þ Vent flashings are damaged and are allowing water to penetrate into home.

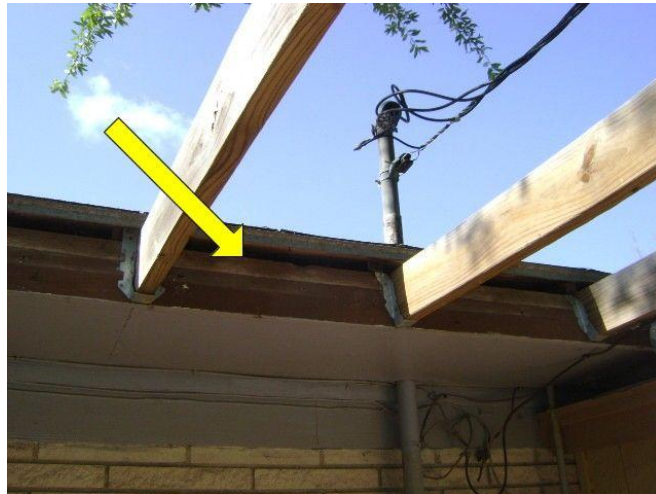
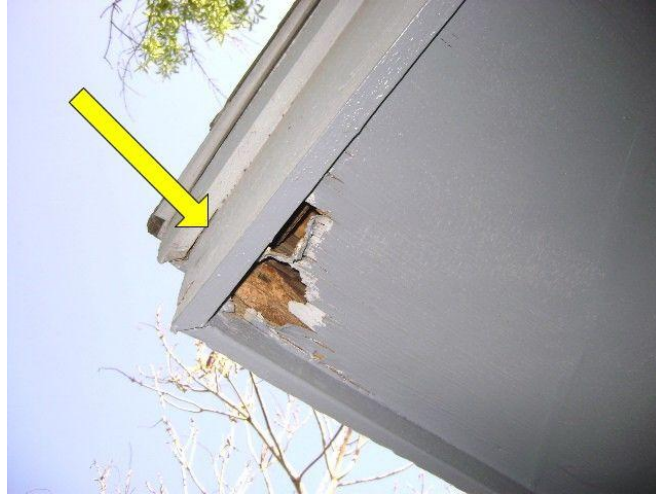
D. Roof Structure & Attic

þ Insulation levels are inadequate.

þ Signs of water penetration seen in various sections of roof rafters.

þ Facia and soffit are damaged in various locations and can allow for water &/or rodents to enter attic.

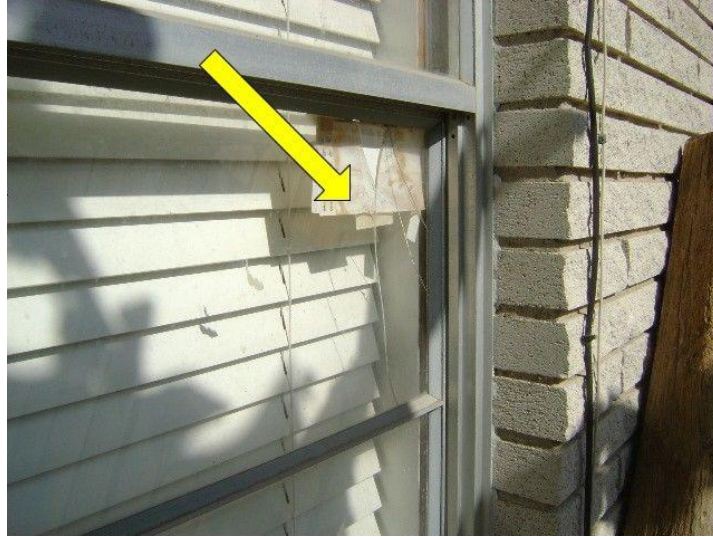
H. Windows - Comments

þ Various broken windows seen in home.

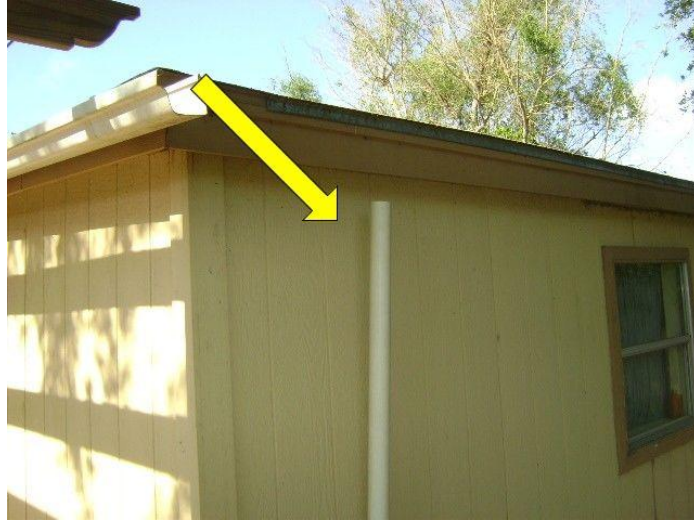
B. Drains, Wastes, and Vents - Comments

- ⌋ Vents need to terminate above roof line.

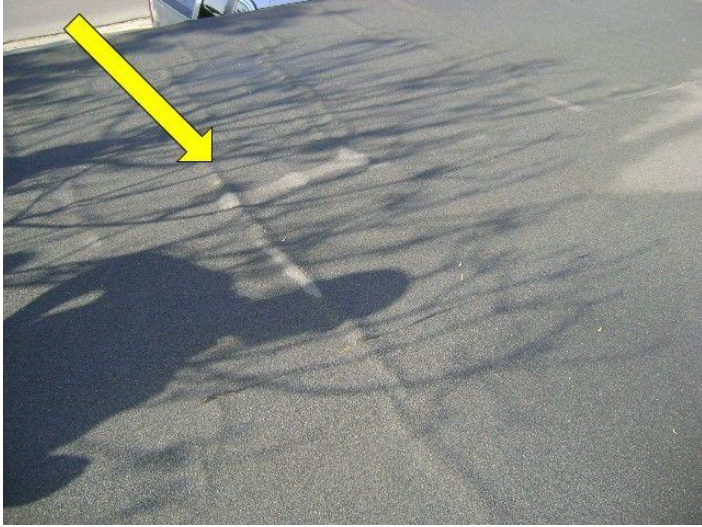
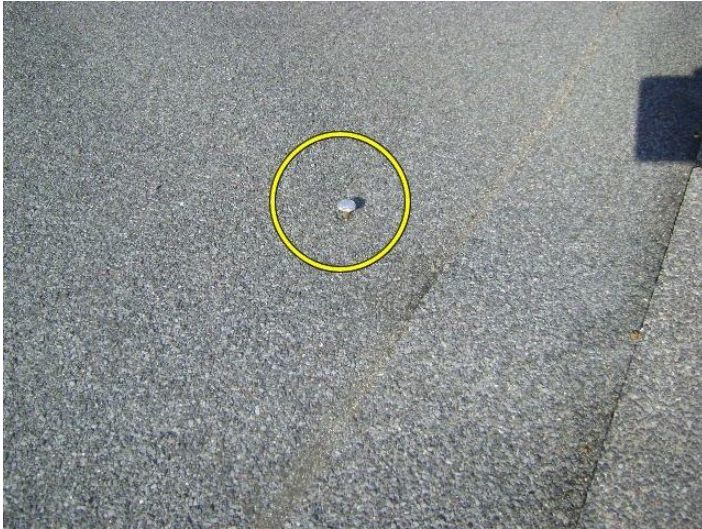
Structural Systems**Roof Covering Materials**

- ⌘ Carport covering is improperly installed with improper material. This must be corrected.
- ⌘ Vent flashings are damaged and are allowing water to penetrate into home.

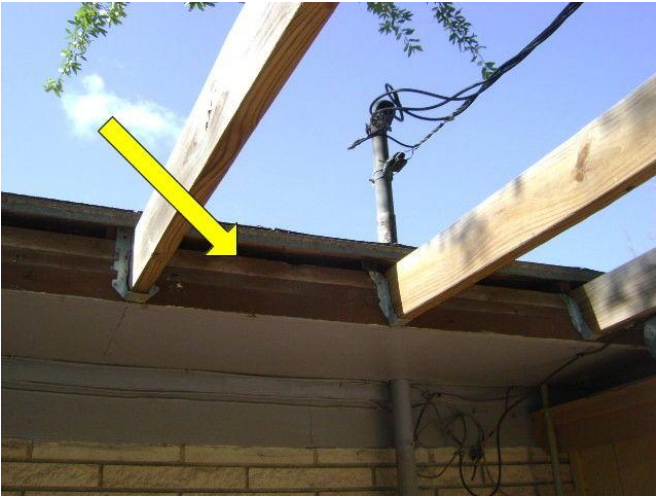
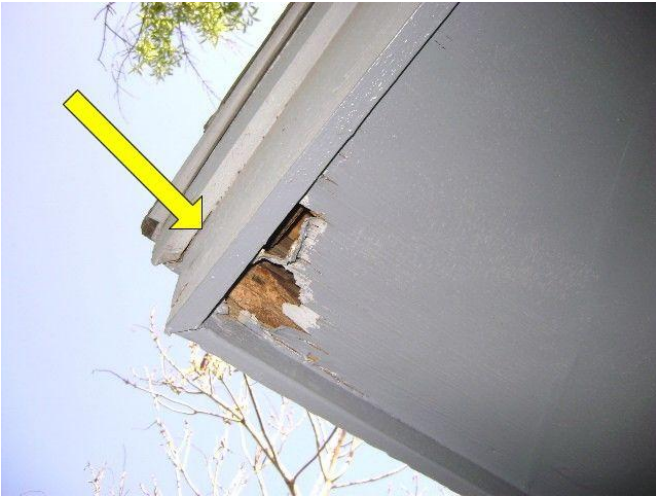
**Roof Structure & Attic****Inspector Notes:**

- ⌘ Insulation levels are inadequate.
- ⌘ Signs of water penetration seen in various sections of roof rafters.
- ⌘ Facia and soffit are damaged in various locations and can allow for water &/or rodents to enter attic.

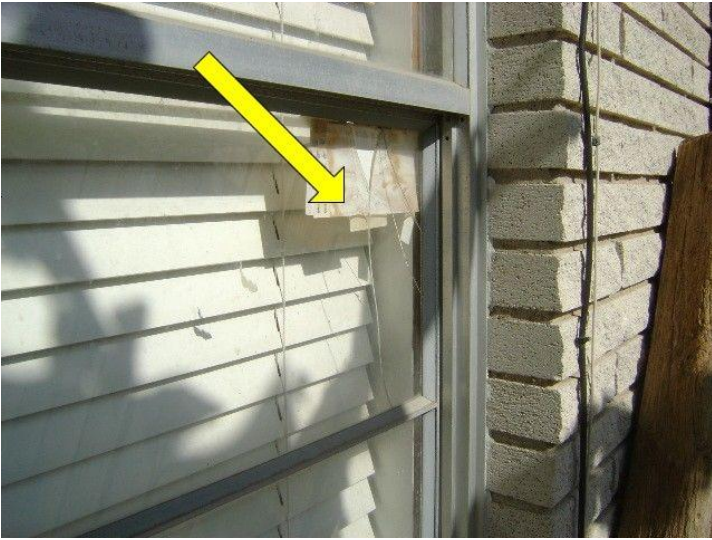
Windows

⌋ Various broken windows seen in home.

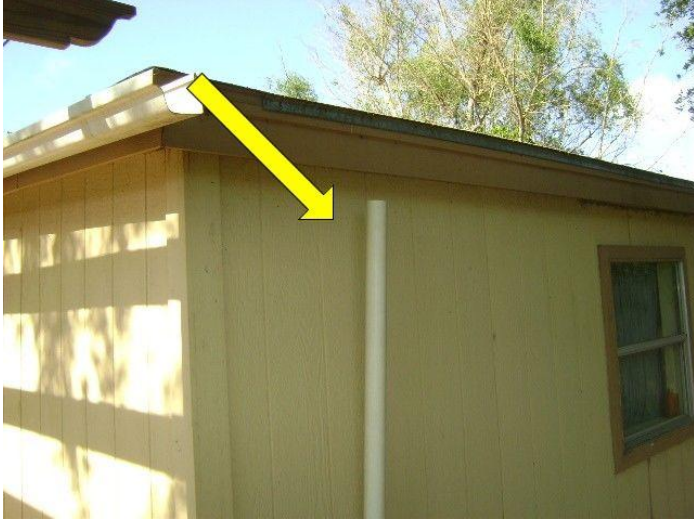
Drains, Wastes, and Vents

⌋ Vents need to terminate above roof line.
